## Rear Hatch button repair - DIY

The hatch button on the C6 is prone to fits of failure and intermittent operation. More often than not it is due to dirt and contamination getting inside the switch. The forum had a great DIY that Ed (pipedreams) had posted but we've lost the pictures. I thought that I would rebuild it for the forum as we head in to the driving season and people start trying to use the button again. While the switch is fairly inexpensive to replace (around \$15.00) it is equally as easy to repair in most cases. You can do this in about 10 minutes.

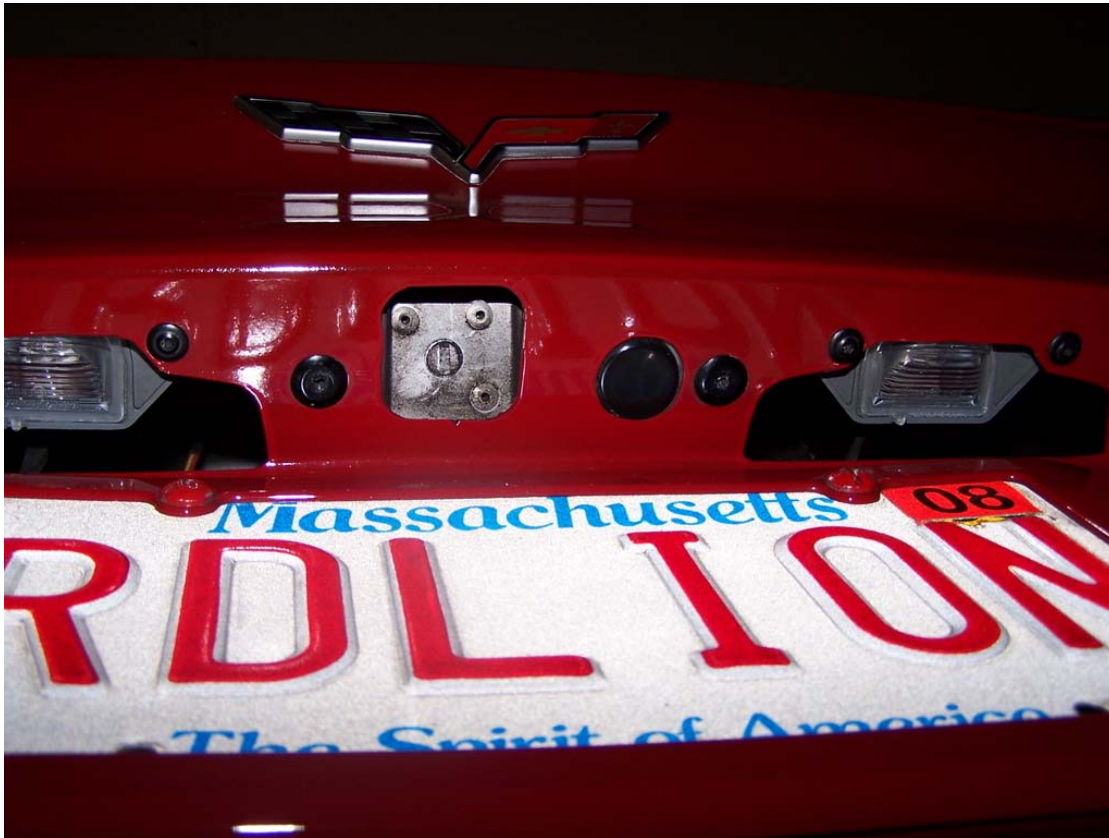
The switch is located above the license plate on the rear fascia.

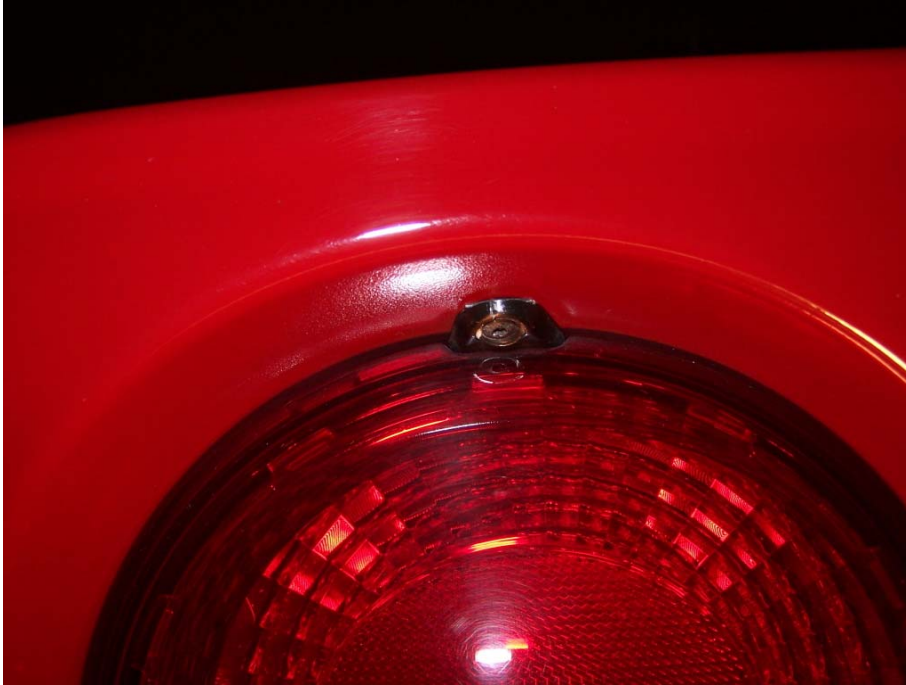
It can be accessed by removing the passenger side inner most tail light.

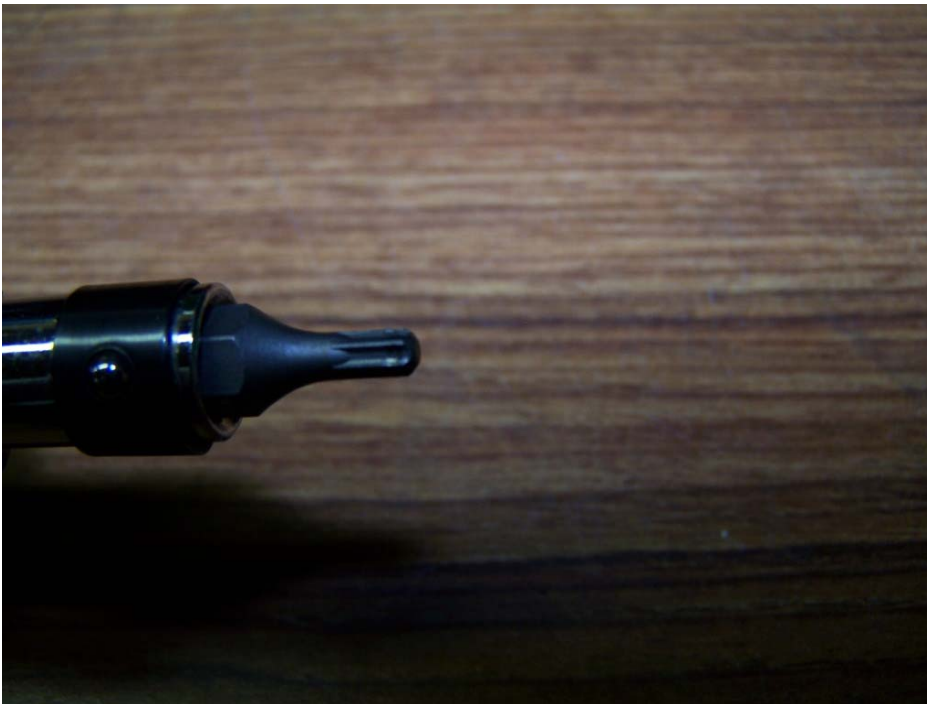
The light is held in place by one T15 Torx screw.

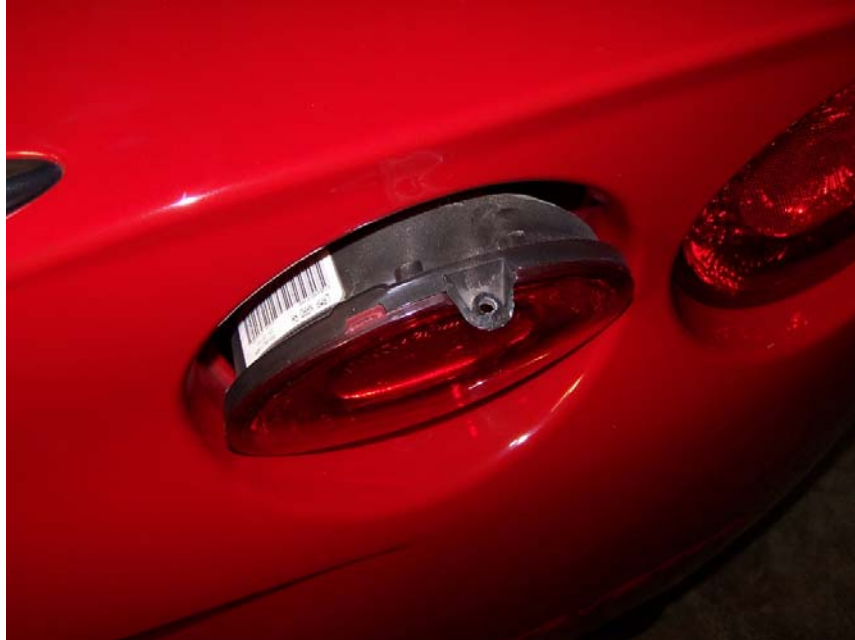
Once the screw is out, tip the tail light forward and remove it.

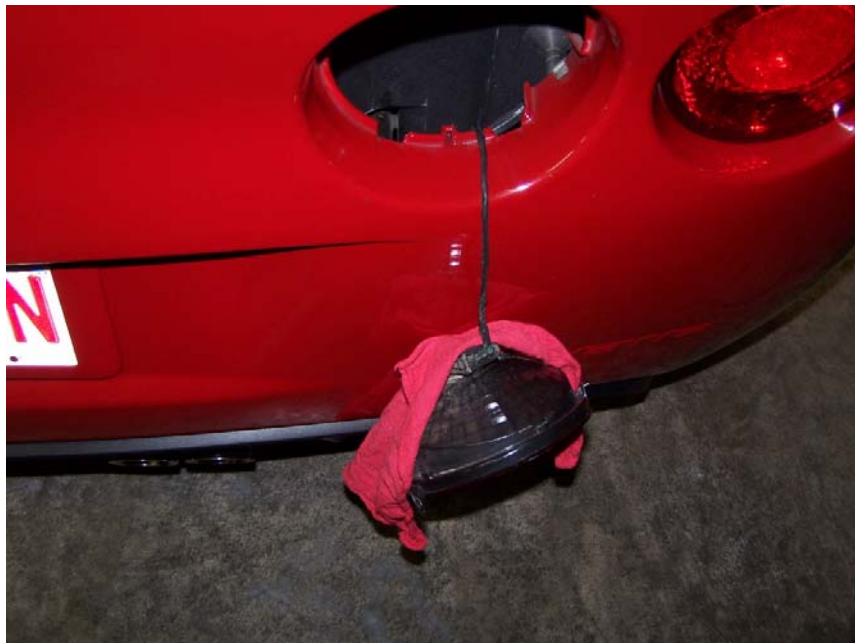
Let the tail light hang down by the harness. I prefer to drape a shop rag over the tail light and rest it against the rear fascia.

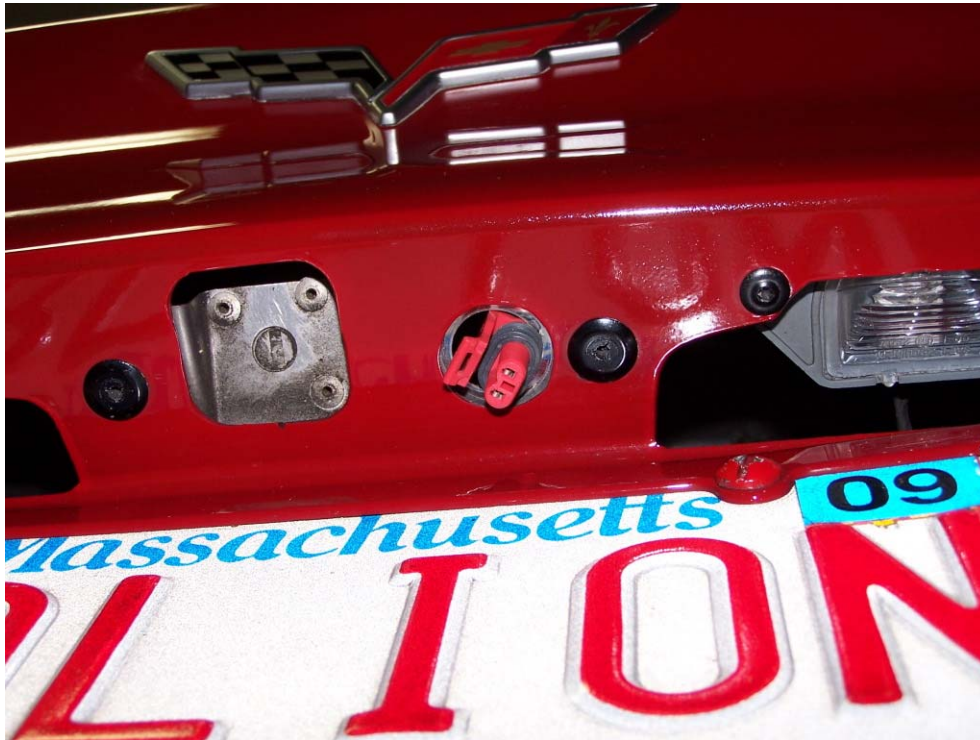
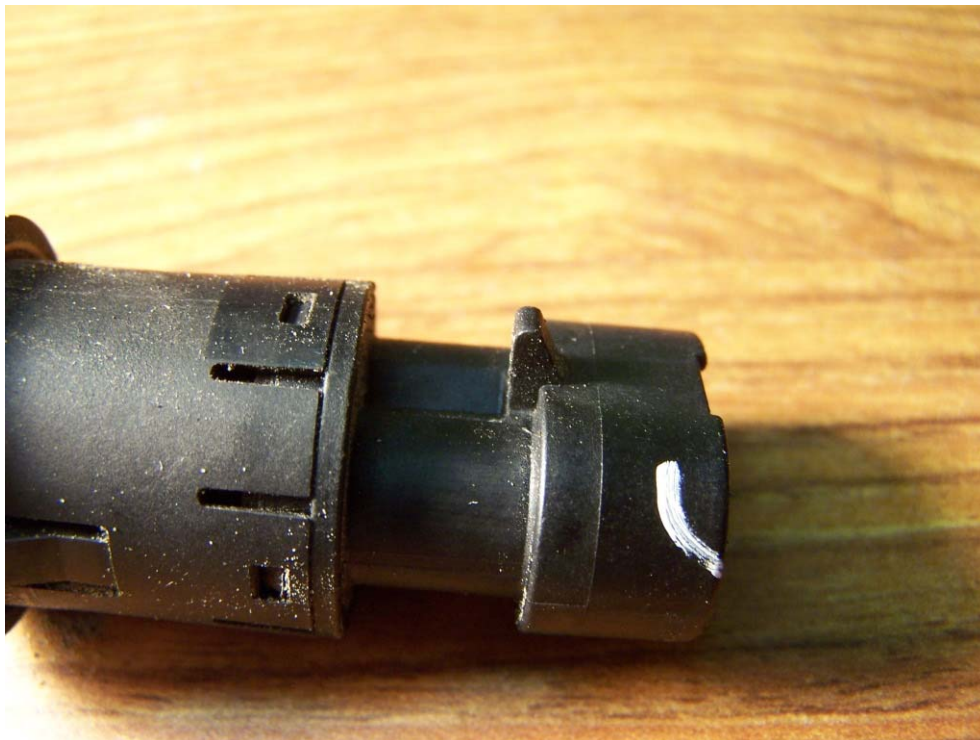
Reach in through the tail light opening and disconnect the wire harness connector from the top of the switch. There is a tab on the side of the connector that must be released to remove it from the switch. You can see the tab in this next photo and the mating detent on the switch housing in the following photo.

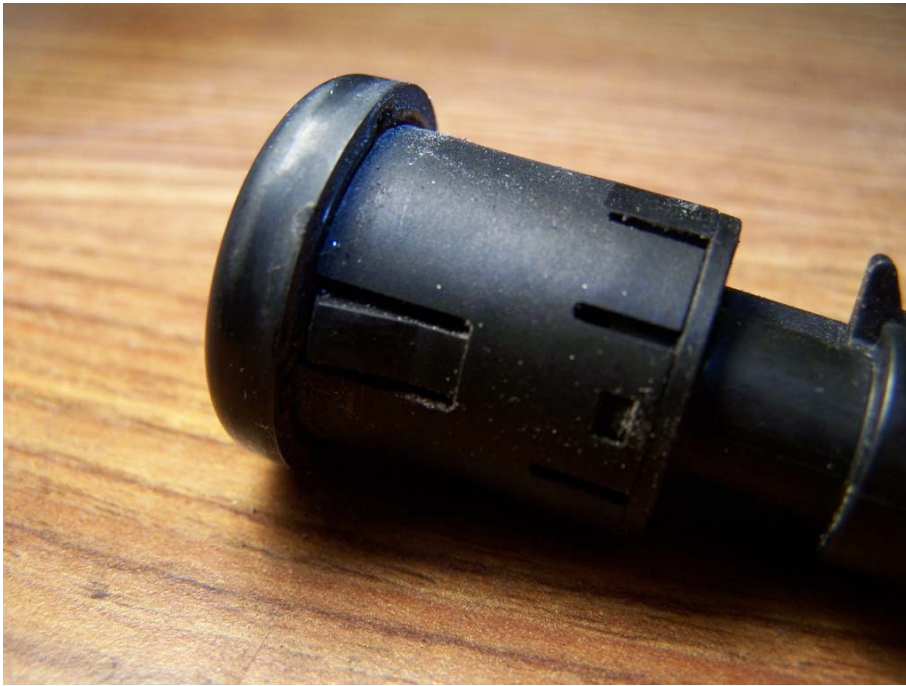
The connector will not fit through the switch opening so you must disconnect it to remove the switch. Once the connector is free there are two press tabs that lock the switch housing in place. You must press these in and the switch housing will drop down out of the rear fascia. You can see the detent in the following picture.

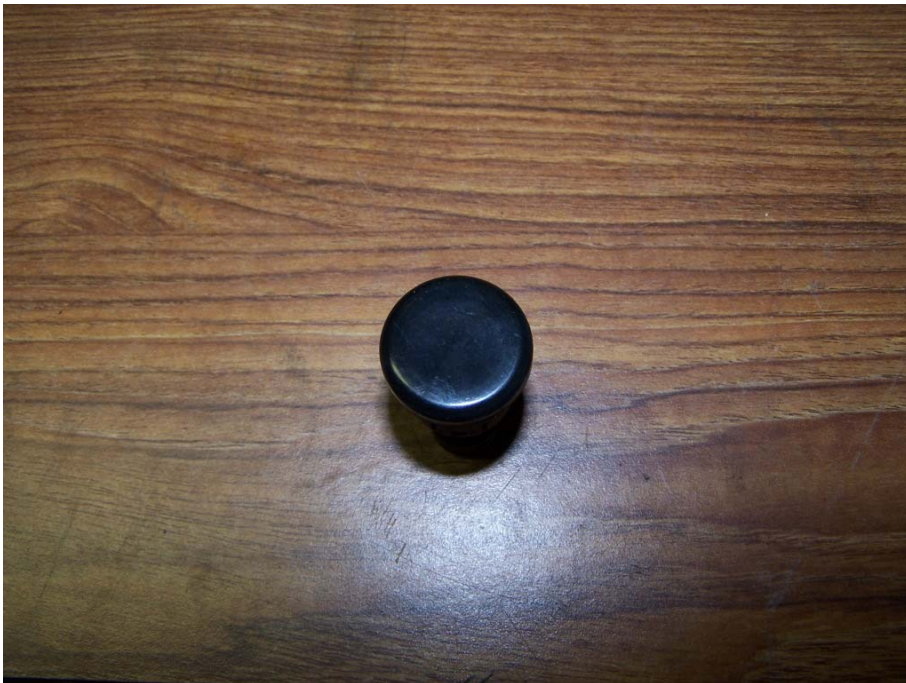
Once you have the switch out you can start the process of repairing it.

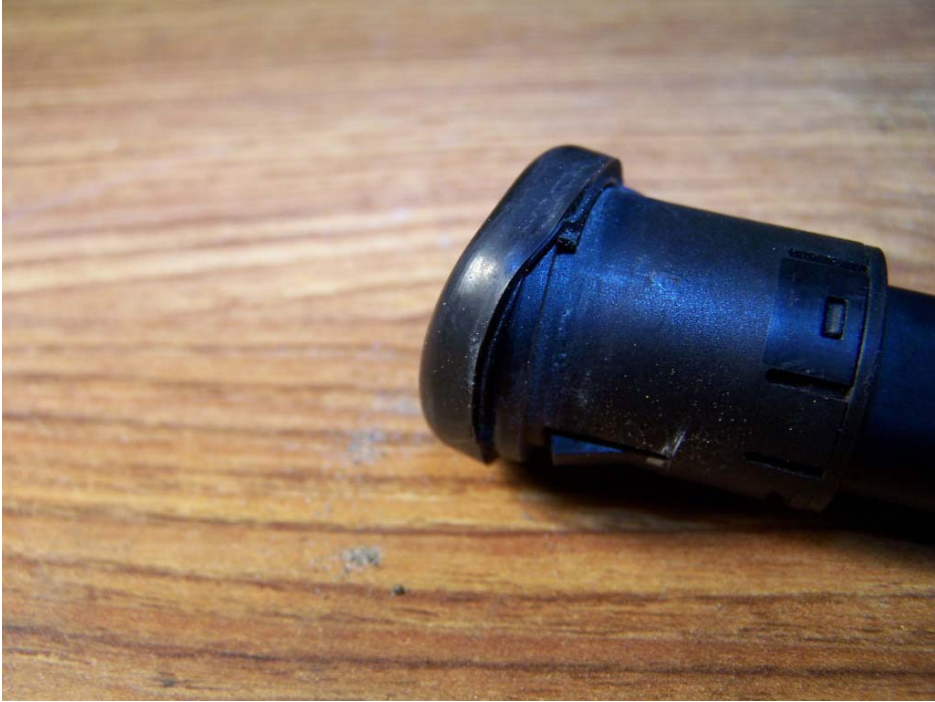
You must remove the rubber cover which is used as a protective cover for the switch. The rubber cover simply peels back.

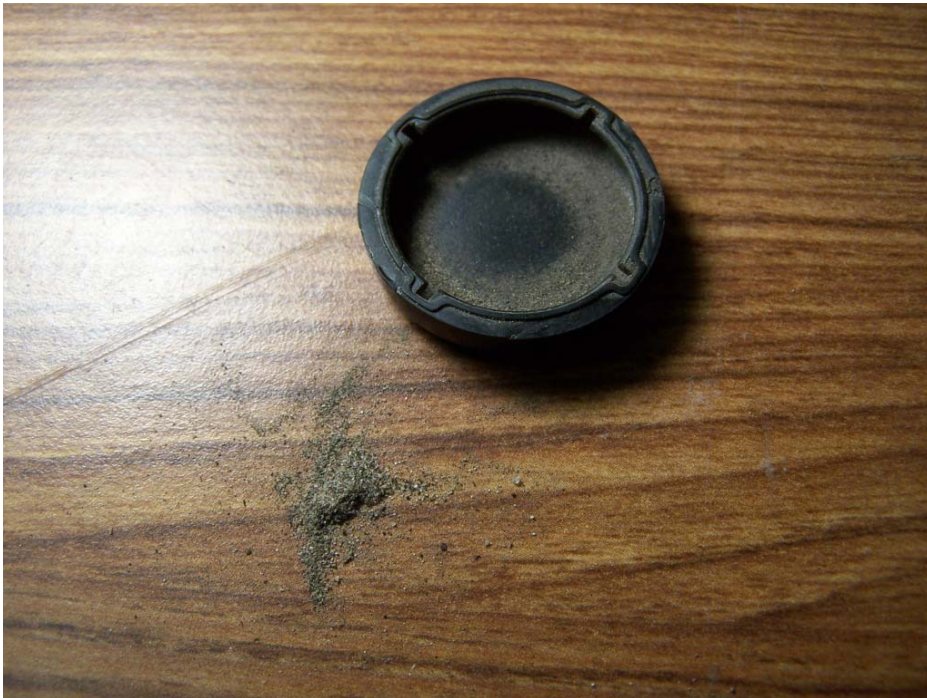
Take a look at what I found in my switch.

This sand and silt is the cause of your switch problems. This was just under the rubber cover. Expect to find more inside.

If your plunger is flush with the surface of the switch it is stuck in the down position and that will be a source of problems. This sand and silt can move around and cause the switch to work intermittently.

Clean out cover and the switch base. Use some compressed air or alcohol and a cotton swab to make sure you get all the sand and contaminants out.

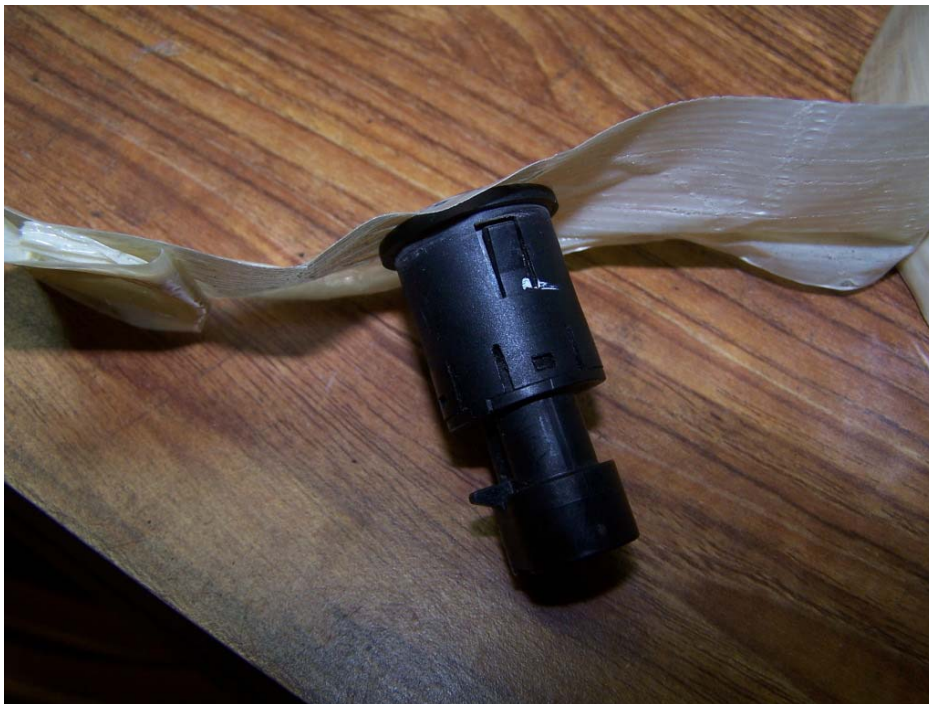
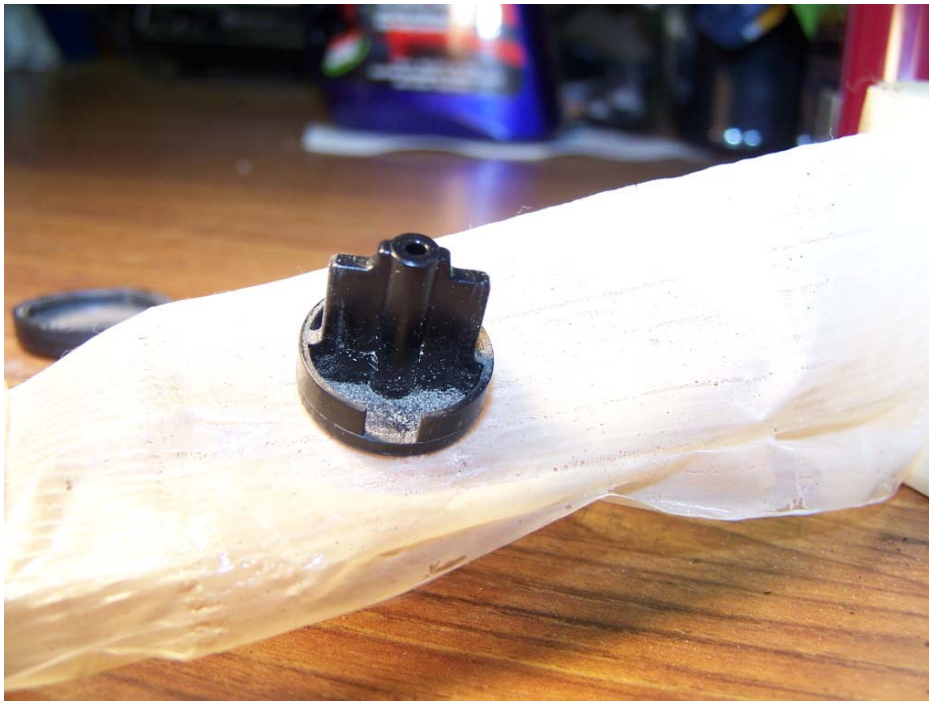
In order to get the plunger out, use a piece of strong tape like duct tape or packing tape. Press the plunger to the sticky side of the tape and pull up on the tape while holding the switch base. This will pull the plunger out of the switch housing which is only a press fit.
